Cilyrychen Quarry - IDO Stage II Registration

Analysis of Tarmac's Application and Technical Statements

**Dinefwr Green Group/Friends of the Earth and the
Campaign for the Protection of the Gwenlais Valley**

June 1997

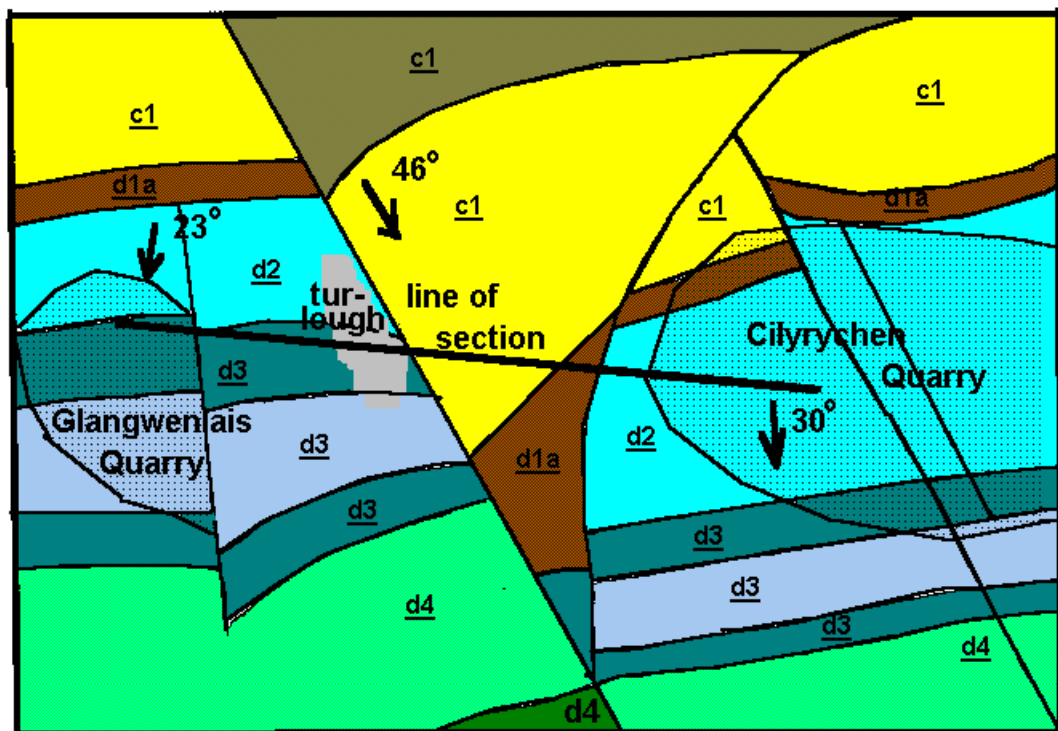
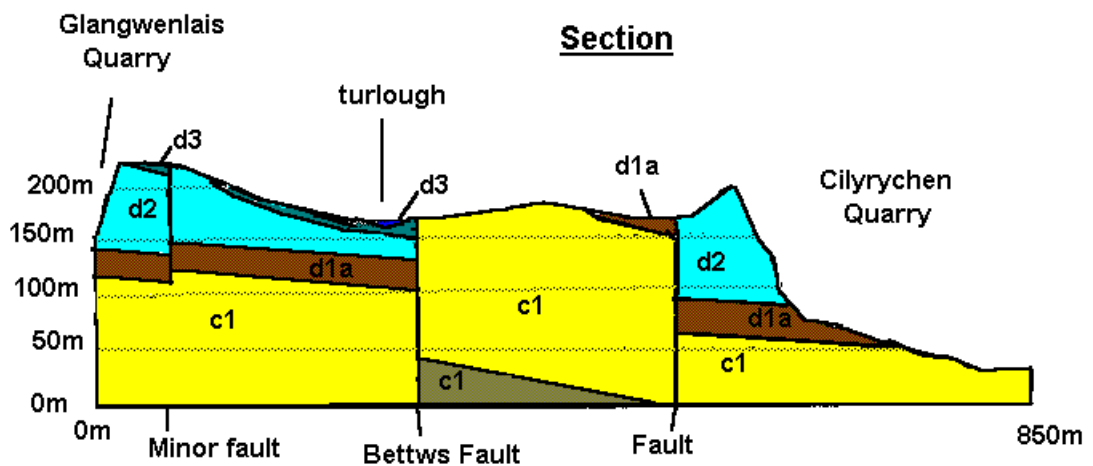
Geological plans

The two diagrams on the following page show a simplified representation of the surface geology taken from the British Geological Survey map. From this a simplified representation of a section between Cilyrychen Quarry and the turlough has been constructed. If the unconformity between the sandstone strata and the limestone strata is highly permeable it would represent a significant conduit for water movement from the west sub-catchment to the east sub-catchment, as identified in the Wimpey report.

The Geological Survey map identifies the limestone/sandstone junction as comprising various 'pebble beds'. The grey grits/plateau beds can be found a few miles to the east and represent the deposition of pebbly material contemporaneous with the deposit of the limestones. The 'pebbly beds' which occur in this area however represent material which formed part of the original erosion surface of the sandstones. From the scaled stratigraphic column the thickness of this strata varies from 0 to 120 metres. From calculations made using the apparent width of the strata at the surface, and the angle of dip, the thickness of the strata in this area would be around 10m to 20m. This would represent a significant conduit for water movement.

Another consideration is the relative hardness and solubility of the junction between the pebble beds and the Cil-yr-ychen Limestone. It is highly likely that solution voids - characteristic of the karst geology - have opened up along this junction. If there were a significant number of solution voids along joints in the limestone, or fully eroded caves (mentioned in the Wimpey Report) this would present an extremely permeable conduit for water movement. However it is likely that such a junction would only exist to the south of the section plotted below, and so water movement between the turlough and Cilyrychen Quarry water be regulated by water flow within the Bettws Fault, and between the Cil-yr-ychen and Llandyfan Limestone Beds.

To conclude this section, it is clear that there is insufficient evidence to prove or disprove a link between the east and west sub-catchment. This would need to be established by direct observation using boreholes to monitor the relative changes in water levels across the upthrust block. If larger void were identified as a possible cause

of groundwater movements between the two sub-catchments then quality analysis could provide clearer information, or a tracer could be used with the agreement of the Environment Agency.
